Alert #: SA 14-16

Date: 10/17/2016

## **FOLLOWING POLICIES AND PROCEDURES**

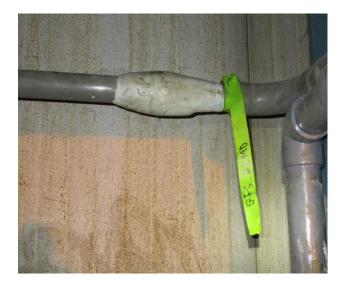
While employees were installing a new line, a line marked for demo was interfering with the process. Employees started to cut the line that was marked for demo and interfering with the job, and realized it was a live line. This resulted in a leak from the line.

- Failure to follow procedure/ work plan
  - The pipe was tagged but *not verified* prior to cutting
  - Did not perform Hazard Identification of demo piping
  - No upgrade to WP/SEA
- Failure of the piping Demo Process
  - Piping was flagged for " GIS Demo"
  - Failure to verify demo piping
  - Multiple tasks in a congested area
- Inadequate Work Planning
  - Inadequate scope of work for the day

Not following policies and procedures could lead to potential incidents like the one described here.
