Alert #: SA 7-16

Date: 6/13/2016

Following Policies and Procedures

SAFETY ALERT

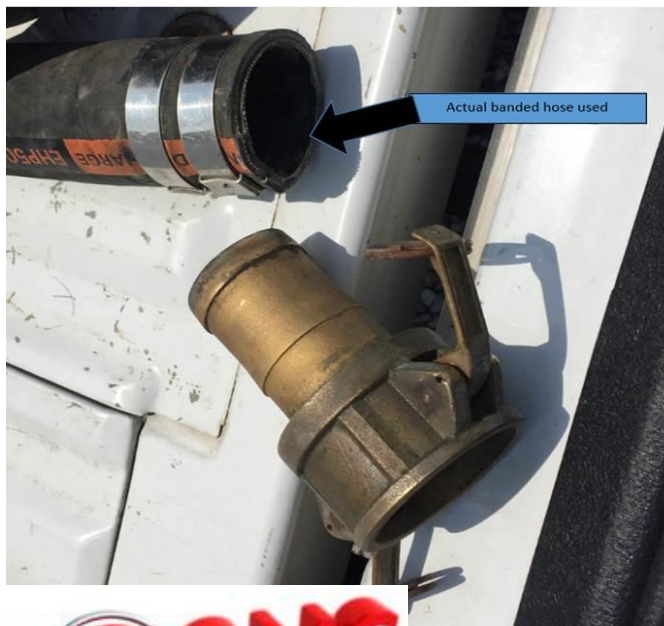
While cleaning out the Liquid Mud Tank (LMT) of a vessel, a 2” discharge hose connected to a manifold was found on the ground, detached from the cam lock attachment. Although the line was providing recycled water only, the cam lock that was banded by the manufacturer whom installed the fitting became loose and allowed the hose to slip causing fluid to leak. An employee noticed immediately when the hose detached and closed the value within seconds. Crews changed out the hose and inspected the deck boards; there was no oil or product on the boards.

- **Failure to follow policies and procedures**
 - It is a GIS policy to use crimped hoses when working with the MudX unit and we must always follow the established policies and procedures.
 - 2” banded hose was used during time of incident.
 - Procedure requires crimped 2” hose to be utilized during this application.
- **Equipment Failure**
 - Banded hose detached from cam lock.
