Alert #: SA 4-18

Date: 04/20/18

Trip Hazards & Material Handling

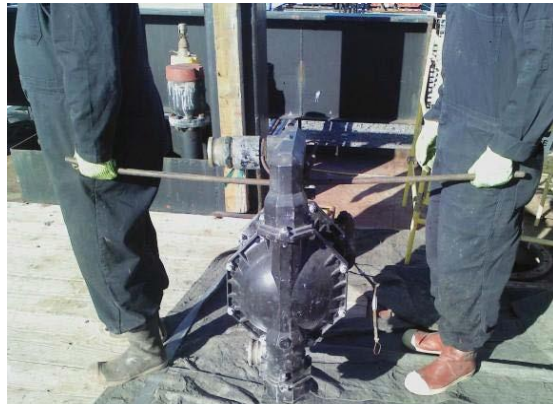
This Safety Alert was prepared as a result of a first aid injury sustained by a GIS employee while changing out a pump they were experiencing problems with. To proceed with this task, the employees utilized a pump carrier to remove the old pump and place in a safe area. The employees then entered the tool house to retrieve the new pump. They used the pump carrier again to carry the new pump to the work location. The IP was in the front controlling his end of the carrier when he stepped forward to exit the tool house. Because the step up in the tool house door required the employee to suddenly change elevations, the pump shifted and the pump foot struck the back of his right boot heel resulting a contusion to his foot.

- This tool house had a “step-up” that was not clearly marked and the hazard was not identified and mitigated on the JSEA.
- As a result of this process, it required the employees to step back down when exiting the tool house which resulted in the unexpected movement of the pump while utilizing the pump carrier to make the transfer.
- Although pump carriers have been an industry norm for performing similar task, the JSEA has been upgraded to include the use of a hand truck “Dolly” to prevent further hazardous situations of unexpected movements of the load.
