Alert #: SA 09-15

Date: 10/12/2015

Neoprene/Rubber Gaskets

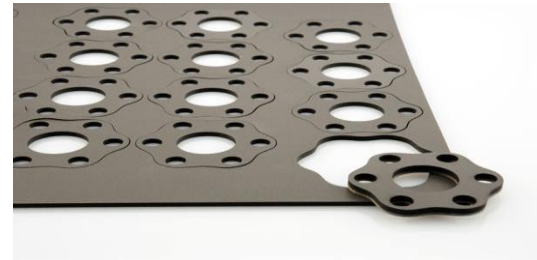
GIS recently placed numerous “shorts” (orders for immediate delivery) for various size neoprene/rubber gaskets with a vendor. The vendor did not follow the specifications submitted by GIS, resulting in the shipment of incorrect “duro hardness” rated gasket material. As the gaskets were installed in the bolted flange joints, the gasket material was squeezed from the effective sealing area. This created a path for future leaks from the joint. In this particular situation, leaks occur because the gasket material is too soft; with a hardness rating of 55-65 instead of the specified 75-85 duro rating. Because of this error, safety of personnel, the surrounding environment and the integrity of numerous flange joints could have been compromised.

1. GIS will request proper documentation on all orders to verify that specifications of the ordered gaskets are correct/accurate.
2. All ordered neoprene/rubber gasket hardness ratings will be verified using a Durometer.
3. All field installations of neoprene/rubber gaskets will utilize a Durometer on site to verify hardness, if improper material specifications are a concern.

4. Training on neoprene/rubber gaskets will be added to the GIS Bolting Training, currently being conducted. This will include the use of a Durometer, ISO reading of the Bill of Materials for the correct gasket rating and signs of an incorrect gasket once installed in the flange joint.
