Alert #: SA 21-24

Date: July 18th, 2024

## ***Being Mindful of Structure Conditions***

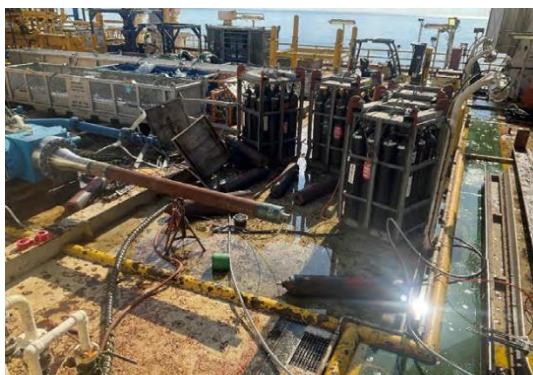
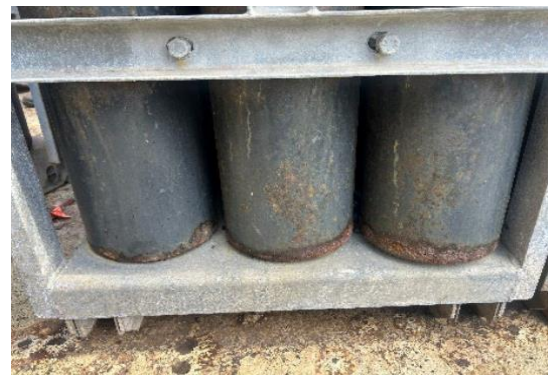
Recently, during some work, there was a high-pressure Nitrogen cylinder within a quad of twelve cylinder on a drill rig floor was ruptured abruptly and without warning. Due to this, the rack was destroyed and the other cylinders were propelled by the blast across the deck around 50 feet from their original locations. While no one was within the blast zone of the cylinder, it is important to understand why an incident such as this one occurred within the first place.

After looking into the incident, it was found that there were many things that went overlooked when it came to the condition of the ruptured pipe. Not only was the pipe's base heavily corroded, but the cylinder itself was 9 years into its 10-year hydrotest cycle. While there were inspections which were done on the pipes, the ruptured pipe was difficult to inspect without disassembly of the entire grid.

With this in mind, it is important that, no matter the time or effort it may take, everything being worked on/with is inspected and cleared to be in proper working condition. There are a few questions one can ask themselves and any other workers in order to prevent future incidents such as this one:

- When were the past inspections done?
- Were there any problems with the previous inspections?
- Is everything currently in accordance with regulations?
- Is everything stored properly?
- Have the conditions of everything being worked with been properly checked?
