Alert #: SA 29-23

Date: August 3<sup>rd</sup>, 2023

## Rigging Failure Leads to Near Miss

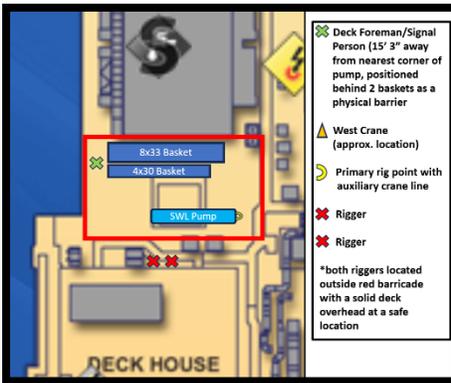
In order to accomplish this, the rigging crew would have to invert the SWLP. While in the process of inverting the SWLP to the horizontal position, the designated signal person (DSP) noticed that a rigging strap was binding against a teflon centralizer causing it to become unstable. The DSP called an all stop to ensure no one was with in the barricaded area and informed the rest of the rigging crew of the potential hazard.

As the team continued with the lift, the pump motor-end was approximately one foot off of the deck when the rigging strap broke free causing part the load, weighing approximately 17,600 LBS total, to drop to the deck.

Due to the complexity of this lift, it was attempted utilizing the crane's auxiliary or fast line and a pneumatic chain hoist to aid in the inversion.

In the future, both the main and auxiliary lines will be utilized during a high-risk lift and chain falls will no longer be utilized. This will eliminate the potential of slings rolling due to force. Furthermore, a greater emphasis shall be place on the location of the applied rigging to ensure that contact is not made with sharp edges or stress points.
