Alert #: SA 36-23

Date: October 23, 2023

## *Air Spider Near Miss*

**SAFETY ALERT**

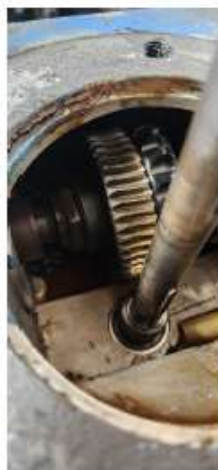
*Image of bronze gear in good condition*

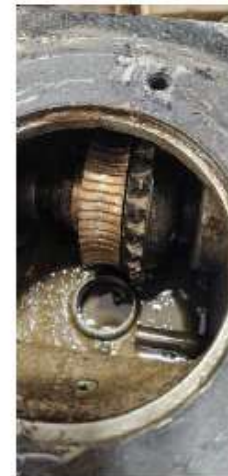
An incident investigation revealed that all the teeth on the bronze gear in the worm drive transmission had sheared off. It is believed that as the operator encountered mechanical issues, the steel worm gear lacked the required tolerances to engage the bronze gear teeth, leading to their shearing off. While the operator was cycling the actuator, the gears intermittently re-engaged until they reached the damaged teeth, ultimately causing a catastrophic failure as the unit was no longer under load, and the remaining teeth on the bronze gear began to slip across the surface of the steel worm gear, shearing them off as the fall momentum increased.

*Image of bronze gear referenced in summary*

The manufacturer recommends inspecting this drive every 30 days (sooner if there are oil leaks) from the filler hole when checking the oil level. The width of the gear teeth is approximately 1/16" (page 15 of the Spider Operator's Manual, Transmission). Moving forward, a visual inspection of the bronze gear will be conducted weekly and documented on the daily inspection checklist. If the edge of a tooth appears to be getting sharp, it will be documented, and the unit will be taken out of service for further inspection by a certified Spider technician.
