Alert #: SA 28-25

Date: July 9, 2025

MISLABELED NYLON STRAPS

SAFETY ALERT

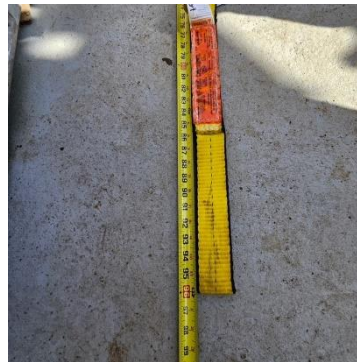
An offshore crew was looking into why their lifts were not level when performing crane operations. The finding was that a nylon strap they were using was eight feet long and labeled ten feet long. The strap was destroyed at the customer's request and a Non-Conformance Report was performed and sent in.

Using slings of **unequal length** during crane lifting operations can create **unstable, unbalanced loads** — significantly increasing the risk of:

- When slings are not the same length, **load weight is distributed unevenly**.
- The shortest sling **takes more load** than the others — possibly beyond its rated capacity.
 - This uneven load path can also cause hooks or lifting lugs to **bend, break, or fail**.

GIS's Quality Department conducted an investigation with the supplier of the straps, and a solution was found to prevent this from happening again.

In the meantime, crews are asked to perform their pre-use inspections with an abundance of caution as there may be more mislabeled slings sent from the GIS Warehouse.
