**Safety
First**

Dropped Object

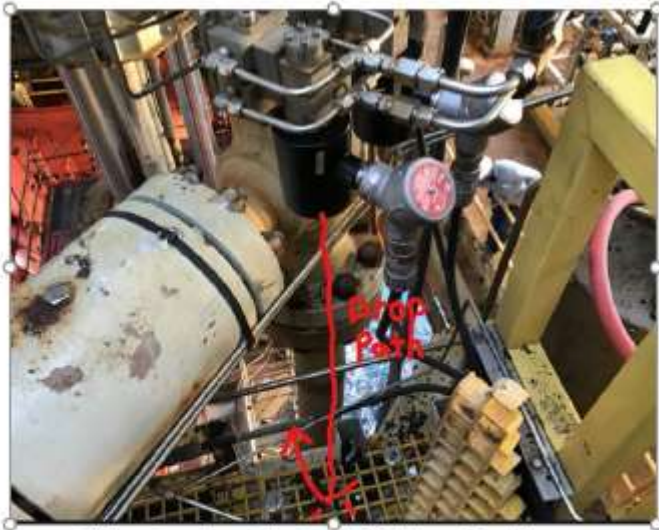
1.6 kg piece of metal sclenoid (DO) drops 5 feet from wellhead to dry crows nest on A1 dry tree and bounces down off the grating

- Safety Stand down with crew, collected pictures and statements of the incident
- Share one pager of incident after internal investigation and synergi handling
- Re-install kick plates on crow's nest platform and ensure all other platforms the same

Procedural/Barrier –Re-enforce that all project work involving potential SIMOPs at various heights within the well bay area must be confirmed with single accountable point of contact (TTR Offshore Project leader) prior to entering well bay area. If they cannot get with the project leader, the OIM must give permission or not, based on a physical check of the SIMOPs at the time of the work.

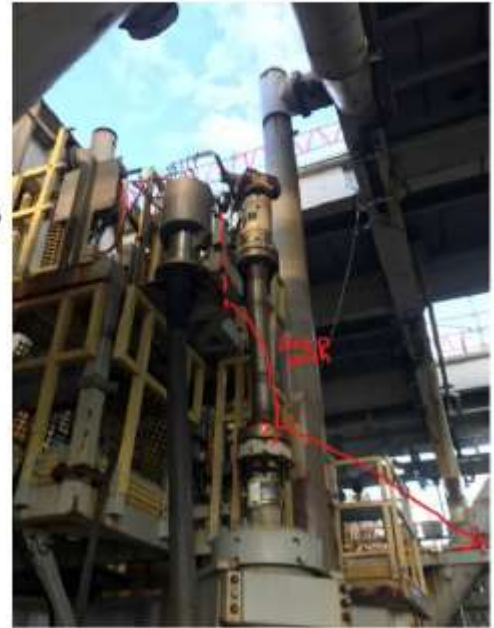
DO then falls another 10 feet and bounces off a flange in the well bay area

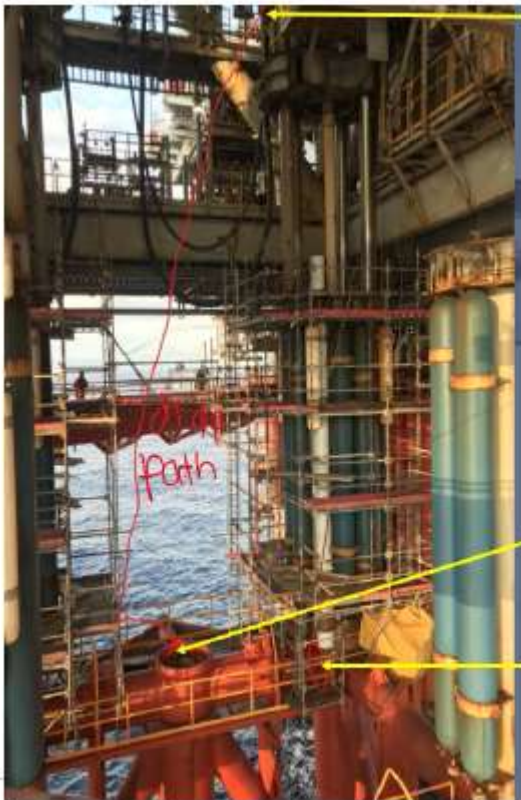
Flange in the well bay area

DO then falls another 40 ft at an angle and bounces off a third point (scaffolding above the A2 riser)

Final resting place of the DO - approx 10 ft away from 3 workers working underneath 3 levels of scaffolding on the plus-10 deck

Location of crew members working below the scaffolding on A1 riser on the plus -10 deck

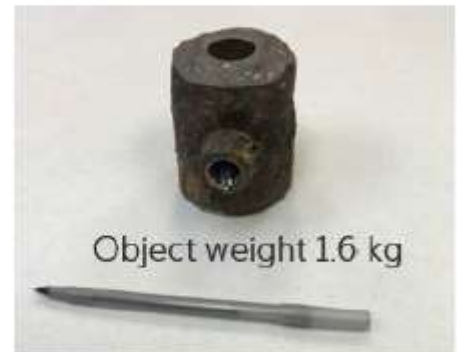
Object weight 1.6 kg
