ALERT NO.: SA 07-12

04/04/12

Release of Fuel Gas

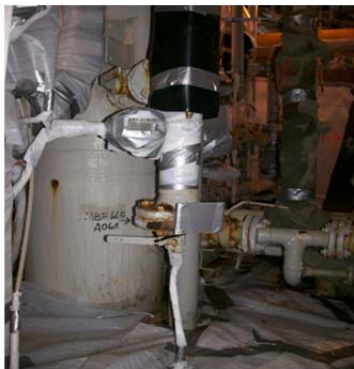
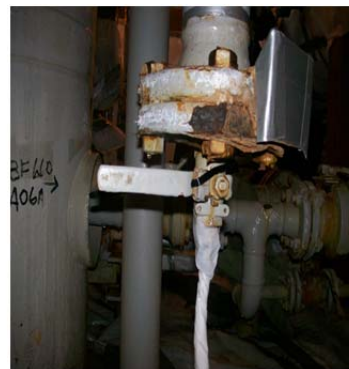
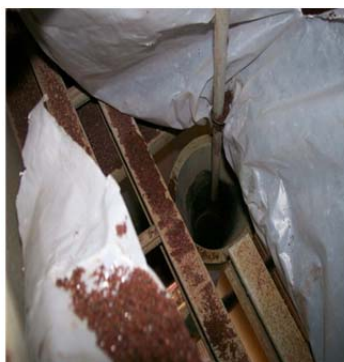
A Blaster/painter reported to the Job Sponsor that he could smell gas on the +65 deck level of Platform A. Facility personnel were notified and began to search for the cause of the leak. Identified that a small valve located on the MBF-660 Skid package was noticed to be open, allowing the Fuel Gas to enter into the facility drain system via a length of tubing. Notifications were made and work was shut down. Crew went to platform B on standby.

- During blast cleaning operations on the skid package; the valve may have been bumped, allowing the valve to open slightly.
- Valve was not noticed or captured in the prejob walkthrough.

- Have the entire crew involved in the hazard hunt of the area.
- Tie wrap or remove any valve handles with permission for the job sponsor .

- Revise the Hazard Id Check List to note all valves need to be closed and locked or noted otherwise.
- Add to the JSEA cover sheet to heighten awareness "Was Hazard ID /Walk through performed and all valves checked and plugged."
