Dropped Object strikes Employee

Recently during a boat transfer, a GIS employee was struck in the arm by a portable target when it fell from the handrail 20 feet above the boat landing. The incident was classified as a "First Aid", but there was potential for the greater injury.

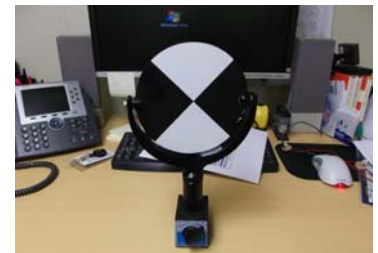
Causal Factor 1: Failure to Identify Potentially Dropped Object

1. Dropped Object Checklist not filled out per Policy
2. "Target" fell and struck employee during a boat transfer.

1. Address dropped objects on WPSEA
2. Complete Dropped Objects Checklist
3. Barricade work area below with danger tape
4. Secure dropped objects before starting job

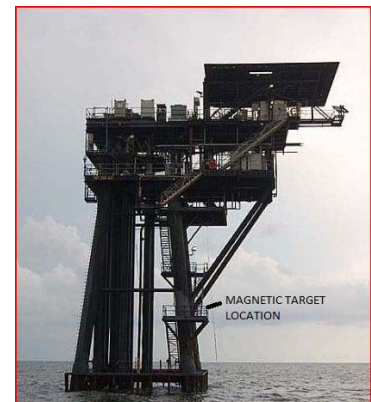
Causal Factors 3: Rigging Procedures

1. Portable target not secured in place

1. Secure target with tie wraps or lanyards as a secondary means
2. Attach tool spider to lanyard when there is a potential for target to fall.
