ALERT NO.: SA 05-13

10/17/2013

Dropped Grating

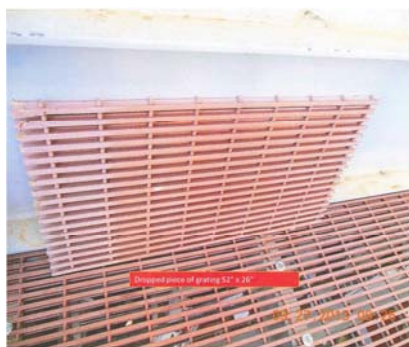
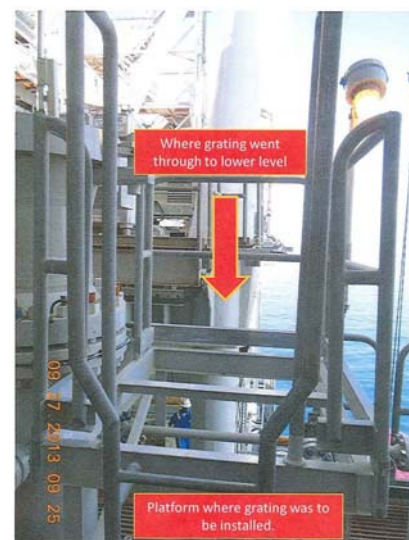
A crew was going to install a 52" X 26.5" piece of grating on a platform by a pig launcher. All but one of the crew members went and gathers tools and materials for the job. One employee stayed and decided to start measuring and marking the piece of grating. When he laid the piece of grating on top of the platform to mark it, one side popped up above the kick plate, and the employee lost his grip. The grating slipped between the handrails, and fell 45' to the deck below. Luckily, no one was working below that area.

Causal Factor 1: Implementation of Standard/Policy/Procedure not effective

Supporting Fact: 2.4 Getting help was mitigated on WPSEA. Crew stated they did not know the employee was starting the job task. Employee admitted to starting task while other employees were getting tools for the task.

Causal Factor 2: Lack of Standard/Policy/Procedure for task

Supporting Facts: Grating was not secured to prevent from falling.
Dropped Objects Checklist was not filled out.

Causal Factor 3: No work plan or risk assessment performed for choices made.

Supporting Facts: Employee felt measuring before the crew returned would speed up the job task.
Employee assumed he could handle it by himself.

Recommended Action(s): Follow WPSEA as written
Never deviate from the WPSEA unless utilizing SWA and upgrading WPSEA

Recommended Action(s): Dropped Objects Checklist should be filled out anytime there is an open hole.
Any object no matter the size needs to be secured to prevent falling.

Recommended Actions: Never Assume, take time to do the job correctly
Prevent Tunnel Vision, Focus on task at hand.
