Alert #: SA 1-18

## CRANE INCIDENT

# SAFETY ALERT

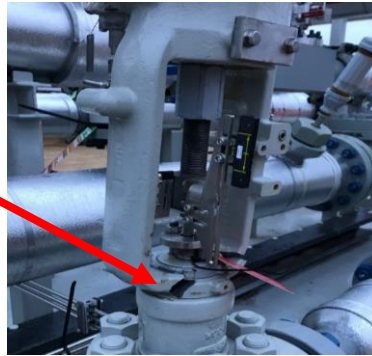
Recently, our company experienced a crane related malfunction that resulted in damage to a skid unit. As the Crane Operator was holding a 48,000# load in place 3' above the ground, the load suddenly fell resulting in a fractured valve housing. The damage associated with the load failure was minor; however, the potential for serious property damage or injury to personnel was evident.

It was later determined through an inspection that brake failure was the cause of the incident. This type of information can and shall only be determined by service professionals qualified to perform this type of inspection and subsequent repair.

Fractured Housing

- ✓ Anytime a lifting device is experiencing technical problems, it shall be immediately taken out of service until a third party service provider can inspect and release the machine for further use.
