Alert #: SA 9-16

## Life Saving Rule Incident Learning

**SAFETY ALERT**

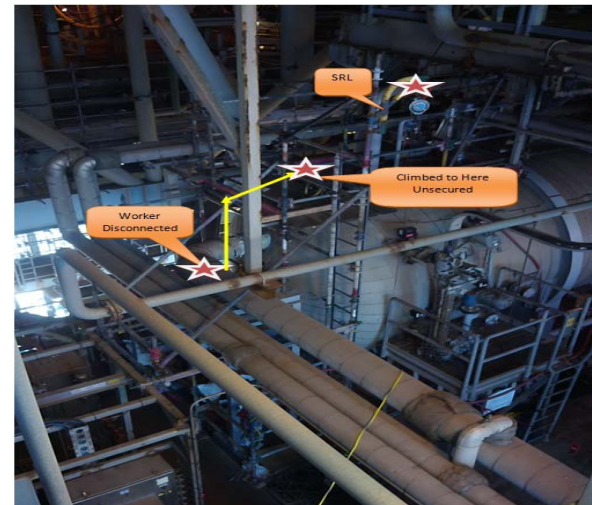
Recently an employee was observed working at height on a scaffold with his fall protection PPE not tied off. The work was stopped, the employee was brought down from the scaffold and escorted to the supervisor's office pending investigation.

- ❖ Employee was working at height on a scaffold with his lanyard tied off to an anchor point
- ❖ Employee needed an SRL to descend from scaffold
- ❖ No SRL was available within reaching distance while connected to the anchor point
- ❖ Other employee had already descended from the scaffold, no one was available to help
- ❖ Employee disconnected lanyard from anchor to access an SRL
- ❖ Employee crossed over handrails with fall protection untied

**FINDINGS: No Life Saving Rule violation was committed.**

- ❖ Employee signed the JSA that specified to work at height on scaffold with 100% fall protection tie off
- ❖ Employee used an SRL to access the work area
- ❖ Employee disconnected from the SRL and tied off lanyard to an anchor point to execute the task
- ❖ The SRL retracted back to the top of the 13 feet ladder used to descend to the work area
- ❖ Another SRL was available 2 feet below the work area
- ❖ Employee identified 3 possible paths the reach the SRL
  - Climbing a ladder 13 feet high untied
  - Moving along a scaffold untied going through obstructed path
  - Crossing over handrails untied

- ❖ Hold SWA/SWI discussions to reinforce the importance of stopping the work when conditions are not adequate for safe execution.
- ❖ Inspect work area around scaffold to ensure a sufficient amount of anchor point and SRL's are installed
- ❖ Employee will participate in fall protection training refresher before being allowed back to work
