Alert #: SA 02 - 22

Date: 02/22/2022

Pinch Points

SAFETY ALERT

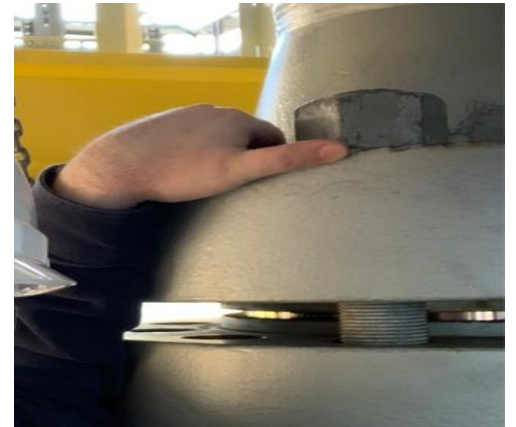
Recently we've had our GIS MODs torquing team working with a Rope Access Team attempting to line up two large flanges. A 2" diameter stud bolt, 18" long and weighing 17.8 lbs., used to align the flanges got hung up in the flange and slid downward approximately 2" through the bolt hole onto the top of the flange as the flange was being aligned. The falling bolt caught the underside of the IP's left thumb between the nut and the flange. The IP was wearing all required PPE including impact gloves at the time of the event and the job was stopped, supervision notified, and the employee reported to the medic's office for assessment.

- Bringing awareness to hand placement during operations including pinch points.
- Supporting the alignment bolt used for initial alignment to prevent the bolt from free falling through the flange.
- GIS will utilize flange alignment tools to help align flanges.
