Alert #: SA 04-25

Date: January 30, 2025

Potential Dropped Object From Cargo Basket

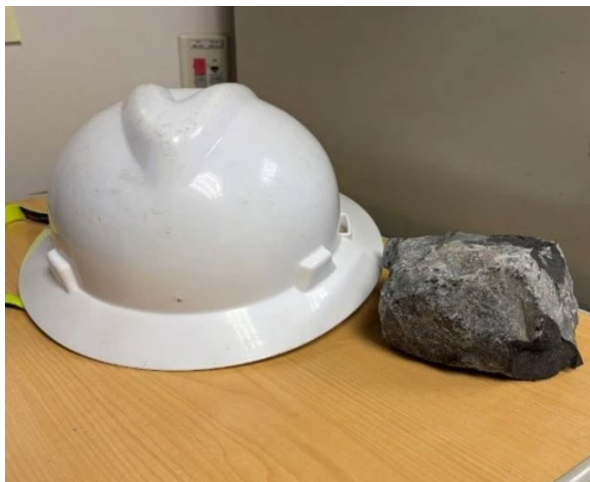
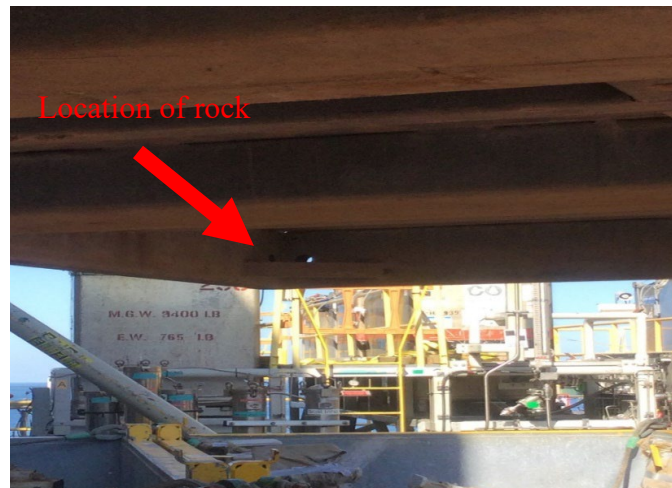
While offloading a boat offshore, the lifting and rigging team noticed a rock lodged into the bottom of a cargo basket between the floor and the support gussets on the frame. This basket was shipped from one of our facilities. The rock measured approximately 5 inches wide on each side and weighed over 4 pounds. If the rock would have worked loose while being lifted, it could have had very serious consequences.

- Flag man on the task called stop work to secure the load.
- The rock was removed from the cargo basket using a pry bar.
- On-site HSE was notified before continuing lifting operations.

- Review Load Securement Policy as needed prior to moving loads.
- Utilize LLCF-046-Load Securement Checklist
- Utilize LLCF-057 Pre-Shipping Checklist
- Ensure debris and unsecured objects are removed from loads prior to lifting
