Alert #: SA 10-22

## *Cable Damage*

Earlier this month, a construction crew was assigned a work scope to install a HP Separator Access Platform and Ladder on an offshore facility.

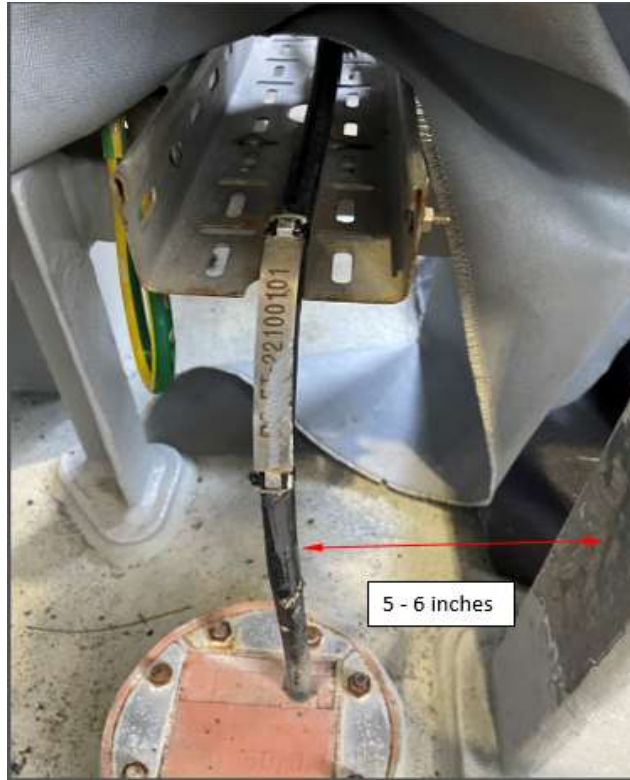
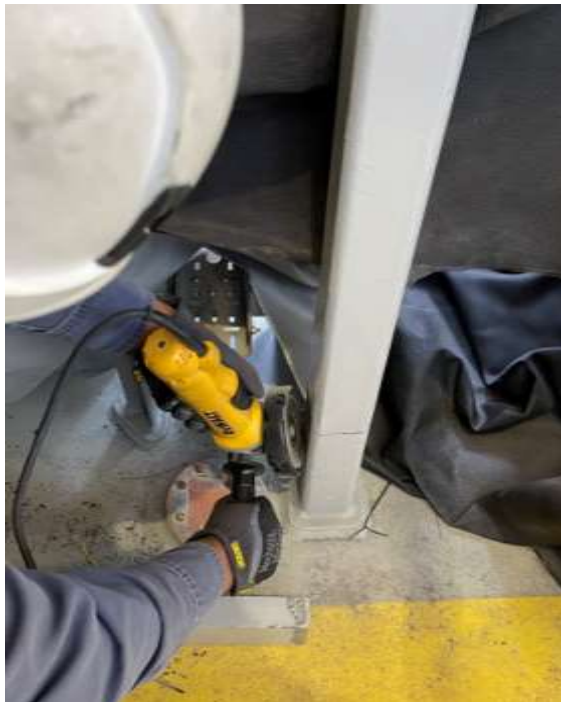
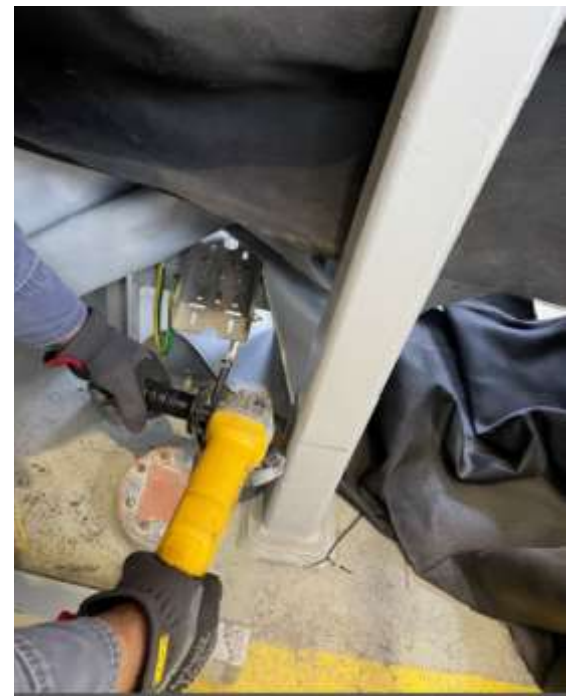
- The permit was not updated when the crew performed a toolbox talk at the job site and found the cable tray tie wraps needed to be cut and the cable tray modified in order to prepare for welding the brace.
- The fitter decided to grind the paint off the beam with the grinder in the horizontal position and did not stop the job to consider an alternative method when the grinder would not fit vertically with adequate clearance between the cable and beam.
- In the process of grinding the paint off, the cable was contacted multiple times causing damage to the cable and tag before the crew decided to stop the job.

1. Inadequate pre job walkdown did not identify the cable as a hazard to be eliminated.
2. Complacency regarding the risks and controls as the cable was not identified as a hazard during the execution of the work.
3. Improper tool was used for the application. A fit for purpose pencil grinder was at the work site but not used.

1. When additional steps outside of the permit is required, stop the job, and involve the AA and upgrade the permit to include hazard recognition and ensuring additional controls are in place before proceeding with the task.
2. Before grinding next to a cable or other equipment that could be damaged, consider removing if possible, if not possible, protect by installing a barrier to prevent damage to adjacent cable or equipment.
3. When damage to cable or other equipment occurs, stop immediately and report it to your supervisor.
