Alert #: SA 20-24

Date: July 9th, 2024

## *Safety with Lifting Magnets*

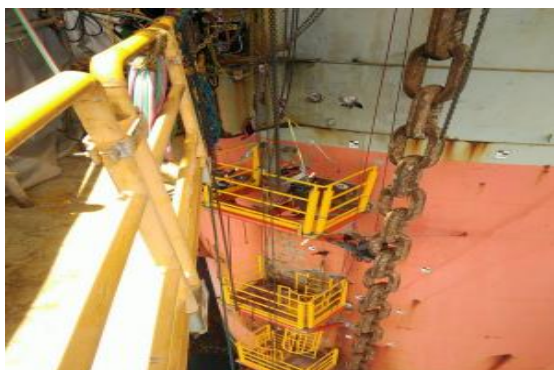
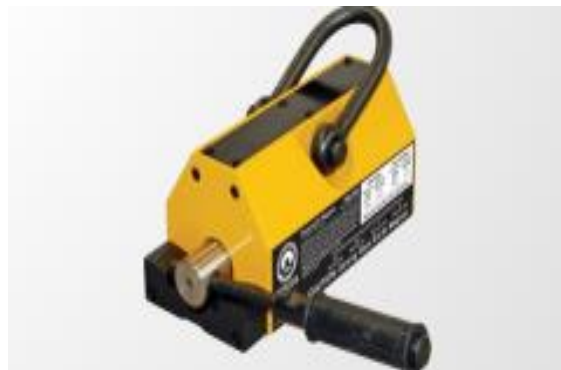
Recently, a crew was working on an escape landing and were utilizing the usage of rigging and magnets to aid in the installation process. During the final fit-up before the tack welding, the magnet which was being used failed, causing it to fall and resulting in the landing shifting in the rigging. The magnet itself had secondary retention, and the RA required exclusion zones below any level work to prevent anyone from being at risk in the line of fire.

Through investigation, two factors were found which led to the falling of the magnet. Firstly, the magnet was utilized as an anchoring point connected to a painted surface. Along with this, a chain-fall was linked from the landing structure to the magnet, resulting in an undesirable side load of over 5 degrees from the horizontal. Due to these two factors, the WLL of the magnet was exceeded, leading to failure. Being able to understand proper usage of tools such as these is integral for workplace safety, and thus it is important to understand how events such as these can be prevented in the future.

- Reiterate the importance of using equipment strictly as intended.
- Incorporate manufacturer guidelines and safety recommendations into internal training programs.
- Regularly review/update exclusion zone protocols to adapt to changing conditions.
- Ensure all personnel involved in rigging operations receive comprehensive training on proper lifting magnet handling/installation.
- Label equipment with proper usage guidelines to prevent misuse.
- Conduct thorough assessments of surface suitability Before applying lifting magnets.
