Alert #: SA 22 - 21

Date: 10/29/21

Crowfoot Becomes Disconnected During Use

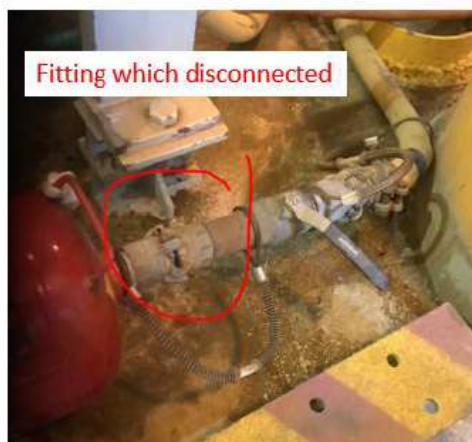
On October 28th, 2021 it was brought to the attention of our Client that a 2" crowfoot connection for a bull hose came loose due the safety tie wire securing the two crowfoot connections breaking. Upon failure of the safety wire that was attached upon installation, the whip checks installed as a safety device in the event of failure stopped the hose from whipping into equipment or people (no injuries or equipment damages). The worker in the area closed the valve staying out the line of fire supplying the air to that bull hose and then got the supervisor and platform involved.

Fitting which disconnected

As a result of this incident, the client has decided that a specific safety pin will now be utilized on every crowfoot and airline connection on all of their facilities.

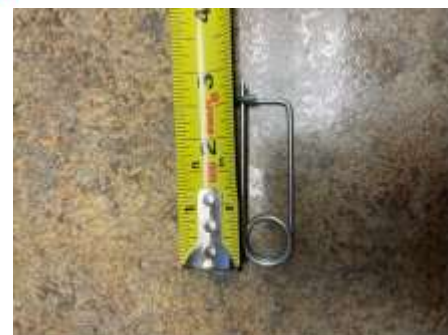
Pin Client Requires

We are aware that we are currently using stainless steel tie wire greater than 18 gauge to help keep these connection in place. However please keep in mind that if a client has a specific requirement, we must follow those requirements unless documented otherwise.
