Alert #: SA 23-24

## High-Pressure Hose Malfunction

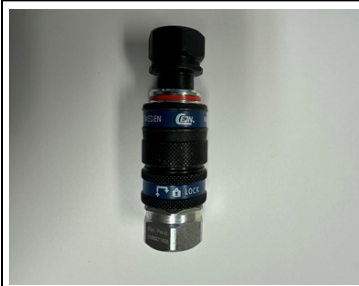
Male Fitting Inserted  
(Unlocked Position)

- Conduct a thorough inspection of all quick connections by attempting to pull apart by hand.
- Notation on JSEA and in Safe to Start Conversation of inspection of quick connection.
- When using Twist Lock Coupling Quick connect, BE SURE that the bottom fitting is twisted BACK to locking position before pressuring up.
- Conduct training with sign-off sheet for all affected personnel

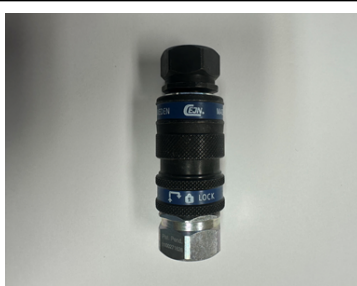
Quick Release Latch in  
Place (Unlocked)

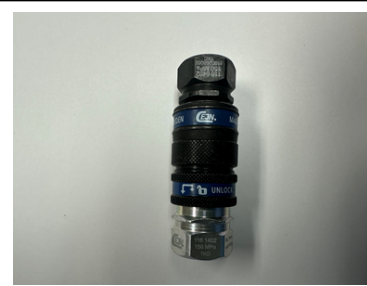
Twist Bottom Fitting  
back into Locked Position
