Alert #: SA 31-25

Date: July 30, 2025

Hole Cover in Deck Falls, Causing Dropped Object Hazard

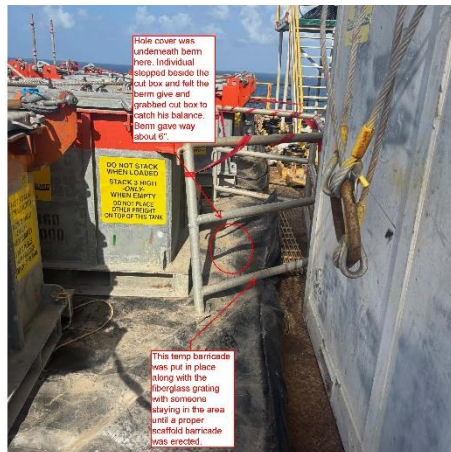
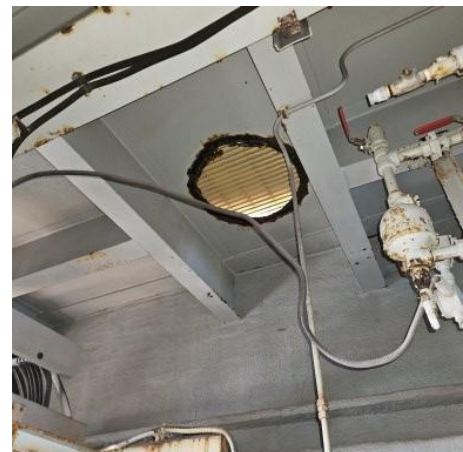
Recently, an offshore crew experienced a dropped object event when a hole cover fell through the hole.

Corrosion over time led to the tabs holding the cover in place to let go, causing it to fall through to the deck below. Fortunately, it did not hit anyone or cause any damage. A black plastic containment berm had been placed over the hole and a cutting bow was landed near it. When a worker walked next to the cutting box, where the hole was hidden by the berm, the tabs welded to the insert cover let go, causing the worker's foot to go about 6 inches deep.

1. **Guardrails** – Sturdy barriers around the opening to prevent falls.
2. **Covers** – Strong, secured panels placed over the opening.
 - They must Support at least twice the expected load (people, tools, equipment)
 - Must be marked “Hole” or “Cover” to warn people.
 - Must be secured so they don't move when stepped on.

Check all deck openings – Make sure they're safe for you and your teammates.
