Alert #: SA 52-26

## Airless Sprayer Hose Whip Incident

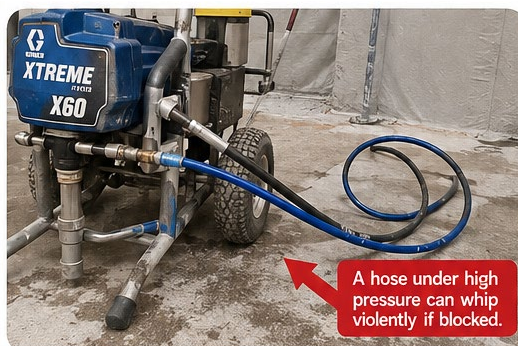
A GIS employee was operating a Graco Xtreme X60 airless sprayer when material stopped flowing due to an apparent hose blockage. The operating pressure was increased in an attempt to restore flow. The hose then moved/whipped unexpectedly and struck the employee in the neck.

The event was classified as a **PSIF (Potential Significant Injury or Fatality Risk)** because the hose could have struck the face or eye, causing a far more serious injury. The equipment is capable of pressures up to 6,000 psi.

- **Never increase pressure to overcome a blockage.** A blockage is an abnormal condition, not a production problem to push through.
- **Stop and safely depressurize/isolate the equipment.** Place the system in a safe state before troubleshooting or breaking connections.
- **Follow the established procedure.** The review found the hose should have been disconnected and manually flushed rather than pressurized against the obstruction.
- **Treat hoses and blocked lines as stored-energy hazards.** Position personnel away from potential release paths and hose-whip zones.

**When the task changes, reassess before continuing.** Stop, discuss the change, update the JSEA/controls as needed, and verify Safe to Start.
