Alert #: SA 09-15

Date: 10/12/2015

Neoprene/Rubber Gaskets

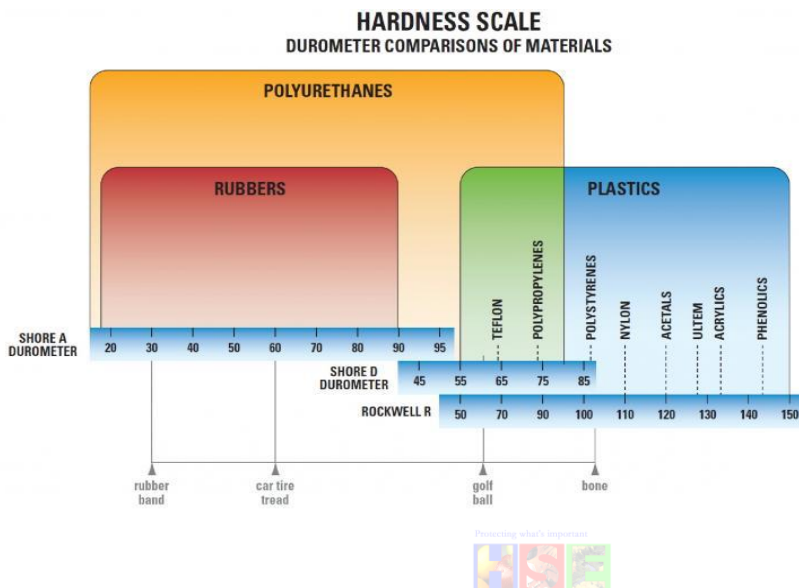
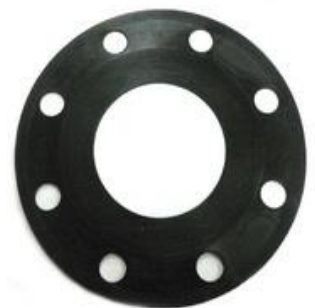
GIS recently placed numerous “shorts” (orders for immediate delivery) for various size neoprene/rubber gaskets with a vendor. The vendor did not follow the specifications submitted by GIS, resulting in the shipment of incorrect “duro hardness” rated gasket material. As the gaskets were installed in the bolted flange joints, the gasket material was squeezed from the effective sealing area. This created a path for future leaks from the joint. In this particular situation, leaks occur because the gasket material is too soft; with a hardness rating of 55-65 instead of the specified 75-85 duro rating. Because of this error, safety of personnel, the surrounding environment and the integrity of numerous flange joints could have been compromised.

1. GIS will request proper documentation on all orders to verify that specifications of the ordered gaskets are correct/accurate.
2. All ordered neoprene/rubber gasket hardness ratings will be verified using a Durometer.
3. All field installations of neoprene/rubber gaskets will utilize a Durometer on site to verify hardness, if improper material specifications are a concern.

4. Training on neoprene/rubber gaskets will be added to the GIS Bolting Training, currently being conducted. This will include the use of a Durometer, ISO reading of the Bill of Materials for the correct gasket rating and signs of an incorrect gasket once installed in the flange joint.
