# Industry Safety Alert

Fall from Scaffold Ends in Fatality

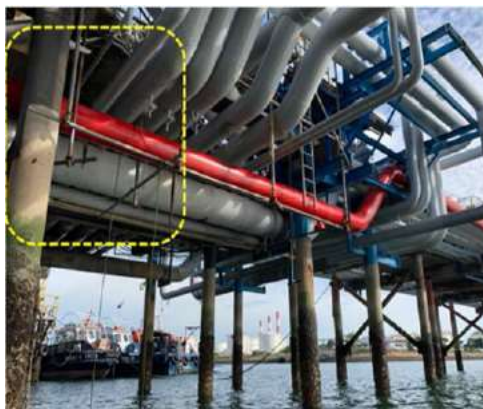
Approximate location where the deceased was working and location of scaffolding which fell.

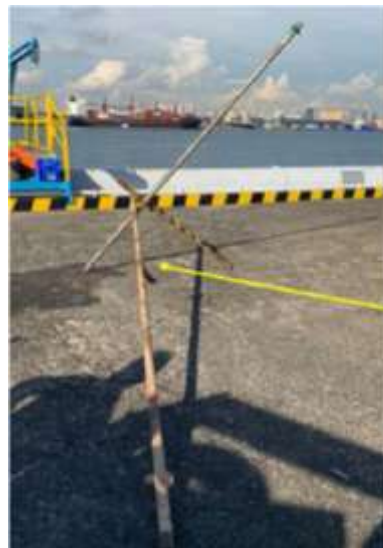
- The body harness was not secured to an available independent lifeline. Instead, it was secured to the scaffolding ledger, which the deceased was working on.

- The beam clamps, which are the critical support ties for the scaffold stability, were found to have been loosened. This contributed to the scaffolding being able to dislodge from the I-beam and fall into the sea.

Fallen scaffolding recovered from the sea.

The deceased was found with body harness attached to the 4-meter ledger of this scaffolding.

- When erecting suspended scaffolding, ensure that you properly secure your body harness to an independent lifeline and correct anchor point.
