Alert #: SA 09-26

Date: February 10, 2026

## **Unexpected Valve Opening**

# SAFETY ALERT

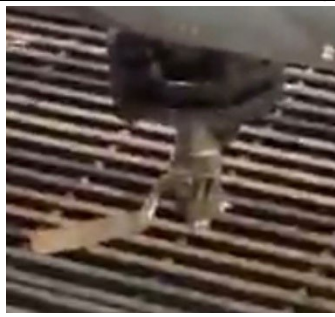
A worker was performing needle-gun work on a glycol reboiler nozzle and saddle when vibration from the activity caused a belly drain valve to inadvertently open. The valve did not have a plug installed, allowing steam and glycol to discharge to atmosphere. The worker evacuated the area immediately. Operations was notified, and the facility was shut in as a precaution. Operations later closed the valve, stopping the release.

- Vibration-intensive work can cause valves to move or open
- All drain valves must be verified closed, secured, and plugged before starting work
- Pre-job checks are critical when working near process equipment

- Inspect nearby valves and drains before power tooling or similar work
- Confirm plugs are installed where required
- Coordinate work with Operations prior to starting
- Evacuate and notify Operations immediately if an unintended release occurs
