Alert #: SA 10-26

Date: February 17, 2026

## Trapped Pressure

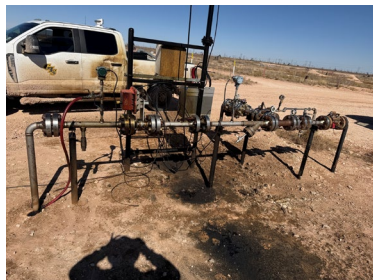
An incident occurred recently involving a high-pressure skid (+/- 1200 lbs.) on a shoreside facility. The skid had been properly isolated and locked out to check a Meter Run joint, and the bleed valve was opened from the tubing transmitters. RTU was checked, and pressure showed zero. Worker started unbolting the flange starting from the bottom and working his way up. Worker was able to take two top bolts out, facing him. He was able to turn the meter joint slightly and then heard pressure escaping. He turned his head slightly to the left, and the pressure gave, spraying oil and coating the worker and nearby equipment. The pressure release lasted approx. 10 seconds.

While no injury or serious damage occurred in this incident, the potential is very significant. The chance that a spark could have been generated and caused a fire or explosion adds more serious consequences to this.

- Always verify zero pressure before breaking a flange.
- Install and verify physical barriers between the flange and personnel when possible
- Ensure only Competent and Qualified personnel are breaking flanges.
- Ensure that the proper GIS Flange Breaking Procedure is followed (Breaking the flange on the side facing away from you).
- Follow all GIS Safety Procedures when performing Line Breaking Operations.

“When loosening the bolts of flanges or covers, loosen those bolts which are farthest from the worker first.”
