Alert #: SA 16-22

Date: June 10th, 2022

Crane Incident

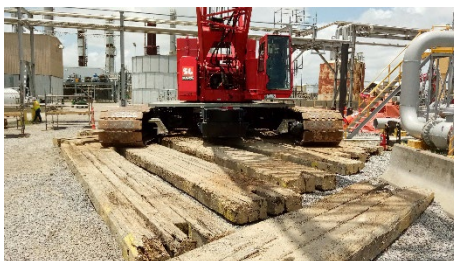
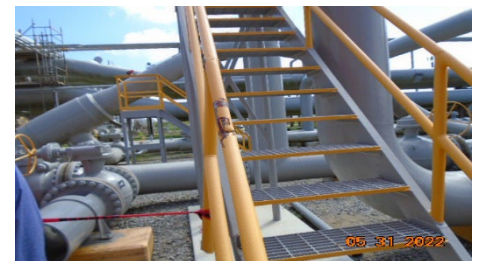
At approximately 9:30 AM, the crane operator, designated signal person and rigging crew attempted a lift of material. During the lift, the crane swung counter to the direction of the stairwell landing. As the crane swung, the counter-weights of the crane contacted the stairwell causing damage. No injuries occurred to personnel and immediately after the incident occurred "Stop Work Authority" was utilized.

Prior to commencing work, crew members shall preform a full swing radius check of any rotating superstructure ensuring that at minimum a 2'-0" clearance is maintained from any objects.
