Alert #: SA 61-26

Date: September 29, 2026

## Verify before Connecting

### P-SIF INCIDENT

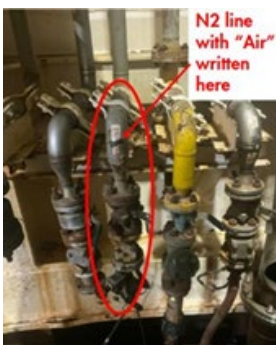
During confined space work, a third-party contractor (NOT GIS) connected an air mover to a nitrogen (N<sub>2</sub>) line because the utility connection was incorrectly marked "Air." The mismatch was caught and corrected before anyone was injured or equipment was damaged. Nitrogen can displace oxygen and create a deadly atmosphere without warning.

- Trace the line to its source and positively verify the service at the point of use. Do not rely on a handwritten mark, a distant label, color alone, or a familiar-looking fitting.
- Confirm the air mover is supplied with the correct air source. Keep air and nitrogen hoses and connections clearly differentiated; never use a shared hose when the service cannot be positively verified.
- Review the JSEA and confined space entry controls with the crew. Confirm ventilation arrangements, atmospheric testing and monitoring, and who will stop the job if conditions or equipment change.
- If identification is missing, conflicting, or uncertain: stop, do not connect, and notify the supervisor or site authority. Have the line isolated and corrected by authorized personnel before restarting.
