Alert #: SA 8-19

Date: May 28, 2019

DUMP TRUCK MAKING CONTACT WITH POWER LINE

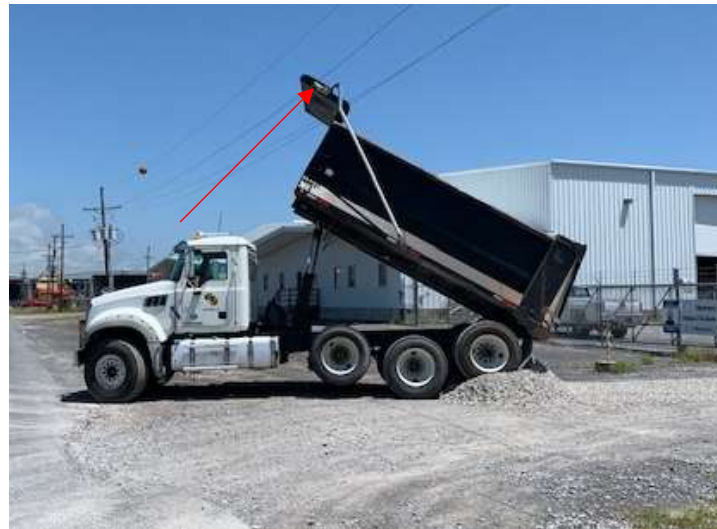
Truck driver was tasked with dumping limestone where the driveway of the facility meets the highway. The driver lifted the truck bed and drove forward to allow the rocks to spread over a larger area. In the process, the truck bed made contact with the power line overhead. The driver immediately stopped the truck when he saw sparks falling. The driver then jumped out of the truck to assess the situation and reported the incident. Entergy was called to de-energize the power lines and help disconnect the cable from the truck safely.

Power Line Making Contact with Truck

(1) Congested Work Area - The area where the rocks were needing to be spread had overhead hazards as well nearby fencing.

Why? - Precautions were not taken for the hazards in the area.

(2) Inadequate Job Planning - Driver decided to unload the rocks directly where the pot holes were located.

Why? - Driver did not take the time to plan out the task and find an alternative way to complete the task safely.

(3) Complacency/Overconfident - The driver knew there were power lines in the area but did not fully consider what could happen.

Why? - The driver did not realize how high his bed was and thought it would have passed under the power line.

Corrective Action - Equipment operating within 15 feet of any power distribution system line, structure, guy wire, switch yard or other energized electrical equipment requires prior clearance by the appropriate Supervisor.

Corrective Action - Always scan your worksite of hazards prior to starting a job. If the task could not be done in the area, complete it in an area where it is safe to do so.

Corrective Actions - Use a spotter in congested work areas to help see blind spots. When working near power lines, equipment must remain at least 15 feet away.
